WHITEHAVEN "WILLIAM" COLLIERY, CUMBERLAND

FINAL REPORT

On the Causes of, and Circumstances attending, the
Explosion which occurred at Whitehaven "William"
Colliery, Cumberland, on the 15th August, 1947

H.M. Chief Inspector of Mines

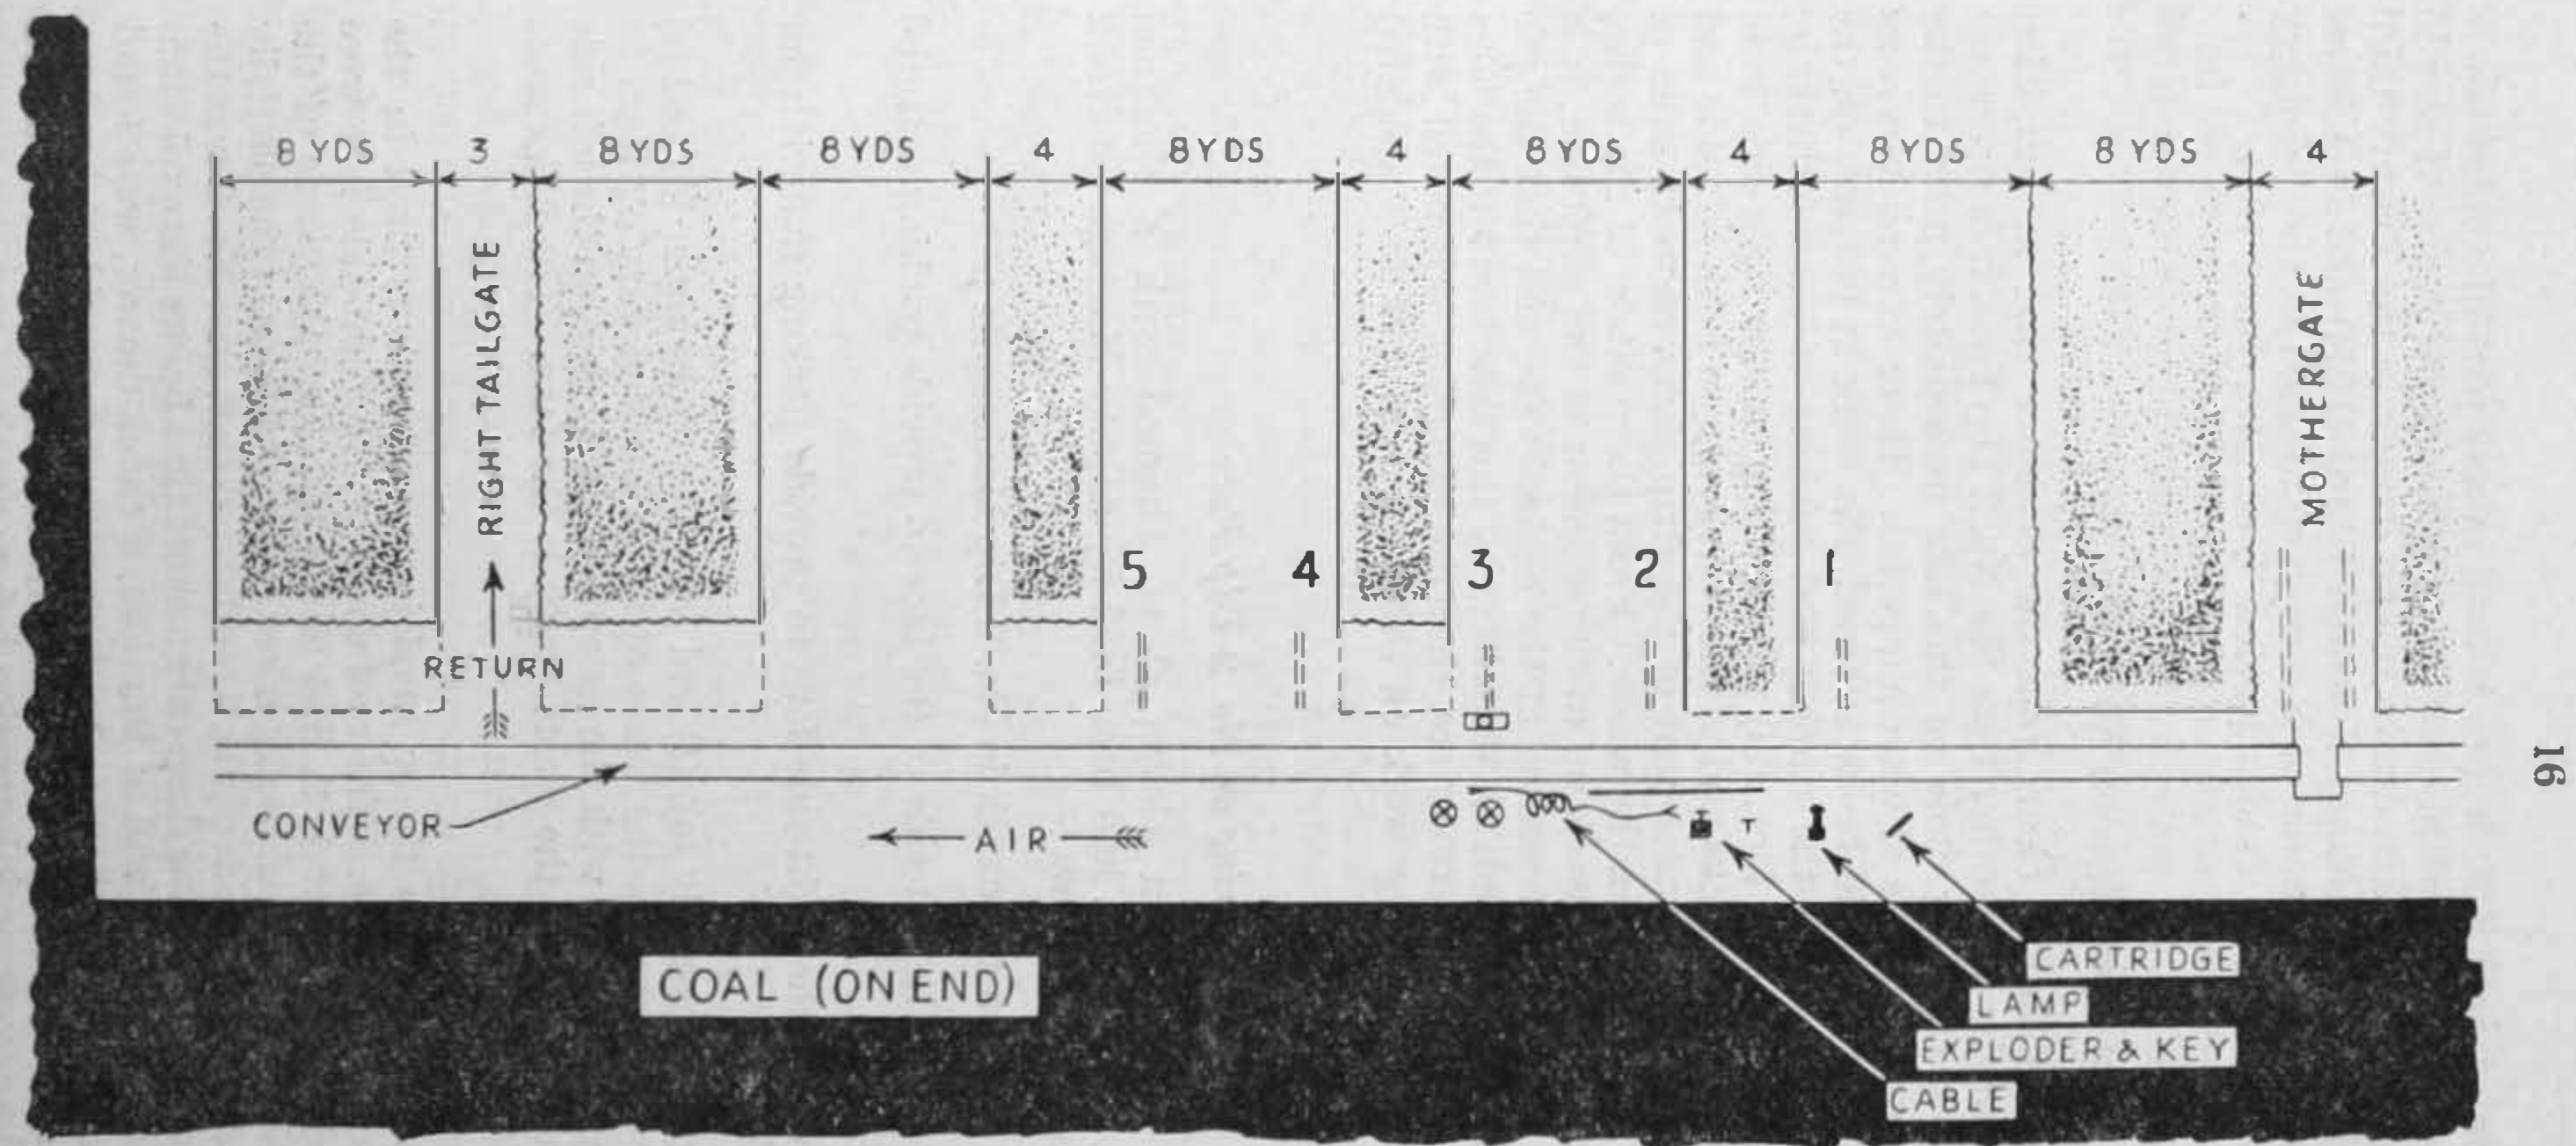
Fig. 1

PLAN OF No. 2 DIP RIGHT HAND FACE
SHOWING THE POSITIONS OF THE SHOTHOLES

43. Careful examination revealed no dangerous features associated with shot-holes 1, 2 and 5. These shots were therefore ruled out as possible causes of delayed ignition. Observations made with regard to shot-holes 3 and 4 make it desirable to describe each in some detail.

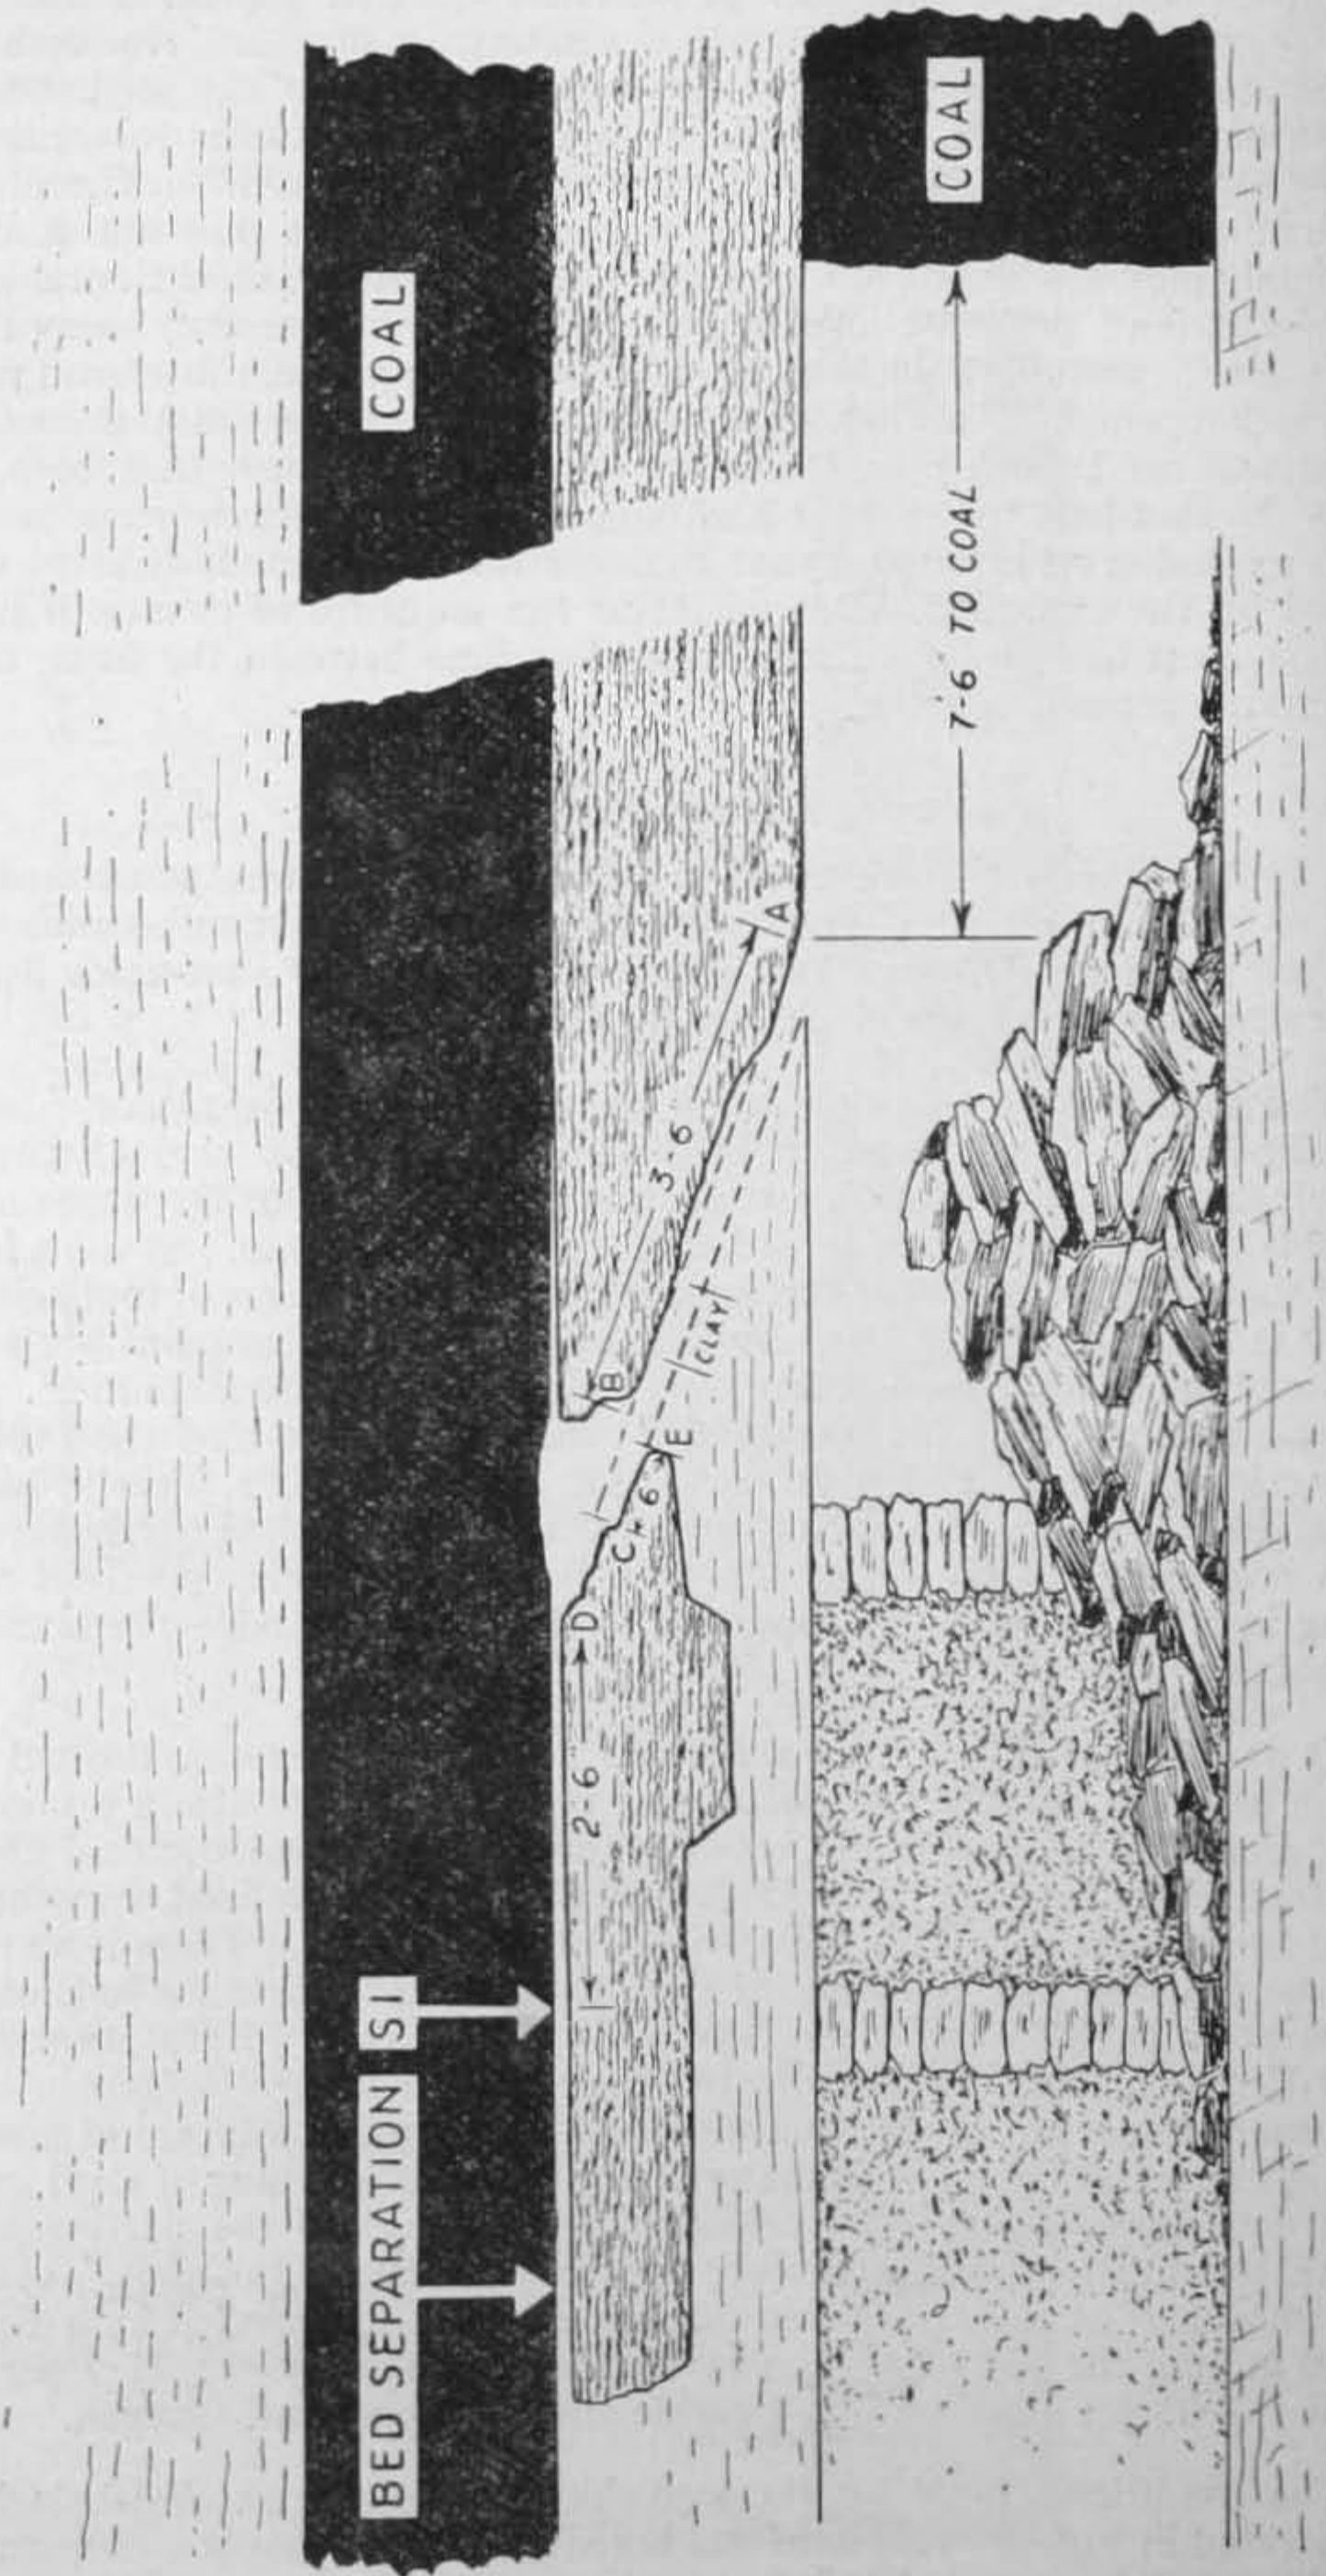
Fig. 2

44. The conditions of shot-hole No. 4, as noted by Drs. Grimshaw, Shepherd and Phillips of the Ministry's Safety in Mines Research Branch on 1st September, are illustrated in Fig. 2. An almost continuous trace, AB of the upper surface of the hole was left on the roof for a distance of about 3 ft. 6 in. At CE a further trace of about 6 in. of the lower surface was observed on a ledge of roof bordering a cavity in a shatter zone caused by the shot. Starting at a point about 5 in. from B and going towards A, there were indications of clay stemming. From this it was assumed that the remaining 11 in. of hole contained the explosive. This length represented two 4 oz. cartridges. The explosive, clearly, had not expended its full energy in breaking down the roof bed, but had partly expended itself in producing the shattering observed beyond the above points B and C, resulting in a cavity extending upwards to the coal bed above the immediate shale roof.

45. It was estimated that there was about 2 in. of shale between the end of the shot-hole as bored and the immediate roof bed. There was also a pronounced opening along the bedding plane between the shale roof and the coal above—a condition that almost certainly existed when the shot was fired, for otherwise it would be difficult to explain the upward shattering effect. There is no reason to suppose that the 2 in. thickness of shale between the end of the hole and the bed separation cavity was broken before the shot. Experimental work at the Buxton Research Station has indicated that when a charge is fired in a hole which runs towards an opening containing an inflammable mixture of firedamp and air, a barrier of 2 in. of solid material (e.g. of stone or a plug of clay) renders ignition very improbable. The proximity of the hole to the parting above, therefore, constituted the only possibly dangerous feature of this shot. A sample of the atmosphere at point S1, taken through a metal tube inserted for a distance of 2 ft. 6 in. into the bed separation cavity showed on analyses: 71.7 per cent. Methane; 7.05 per cent. Carbon Dioxide and 3.67 per cent. Oxygen.

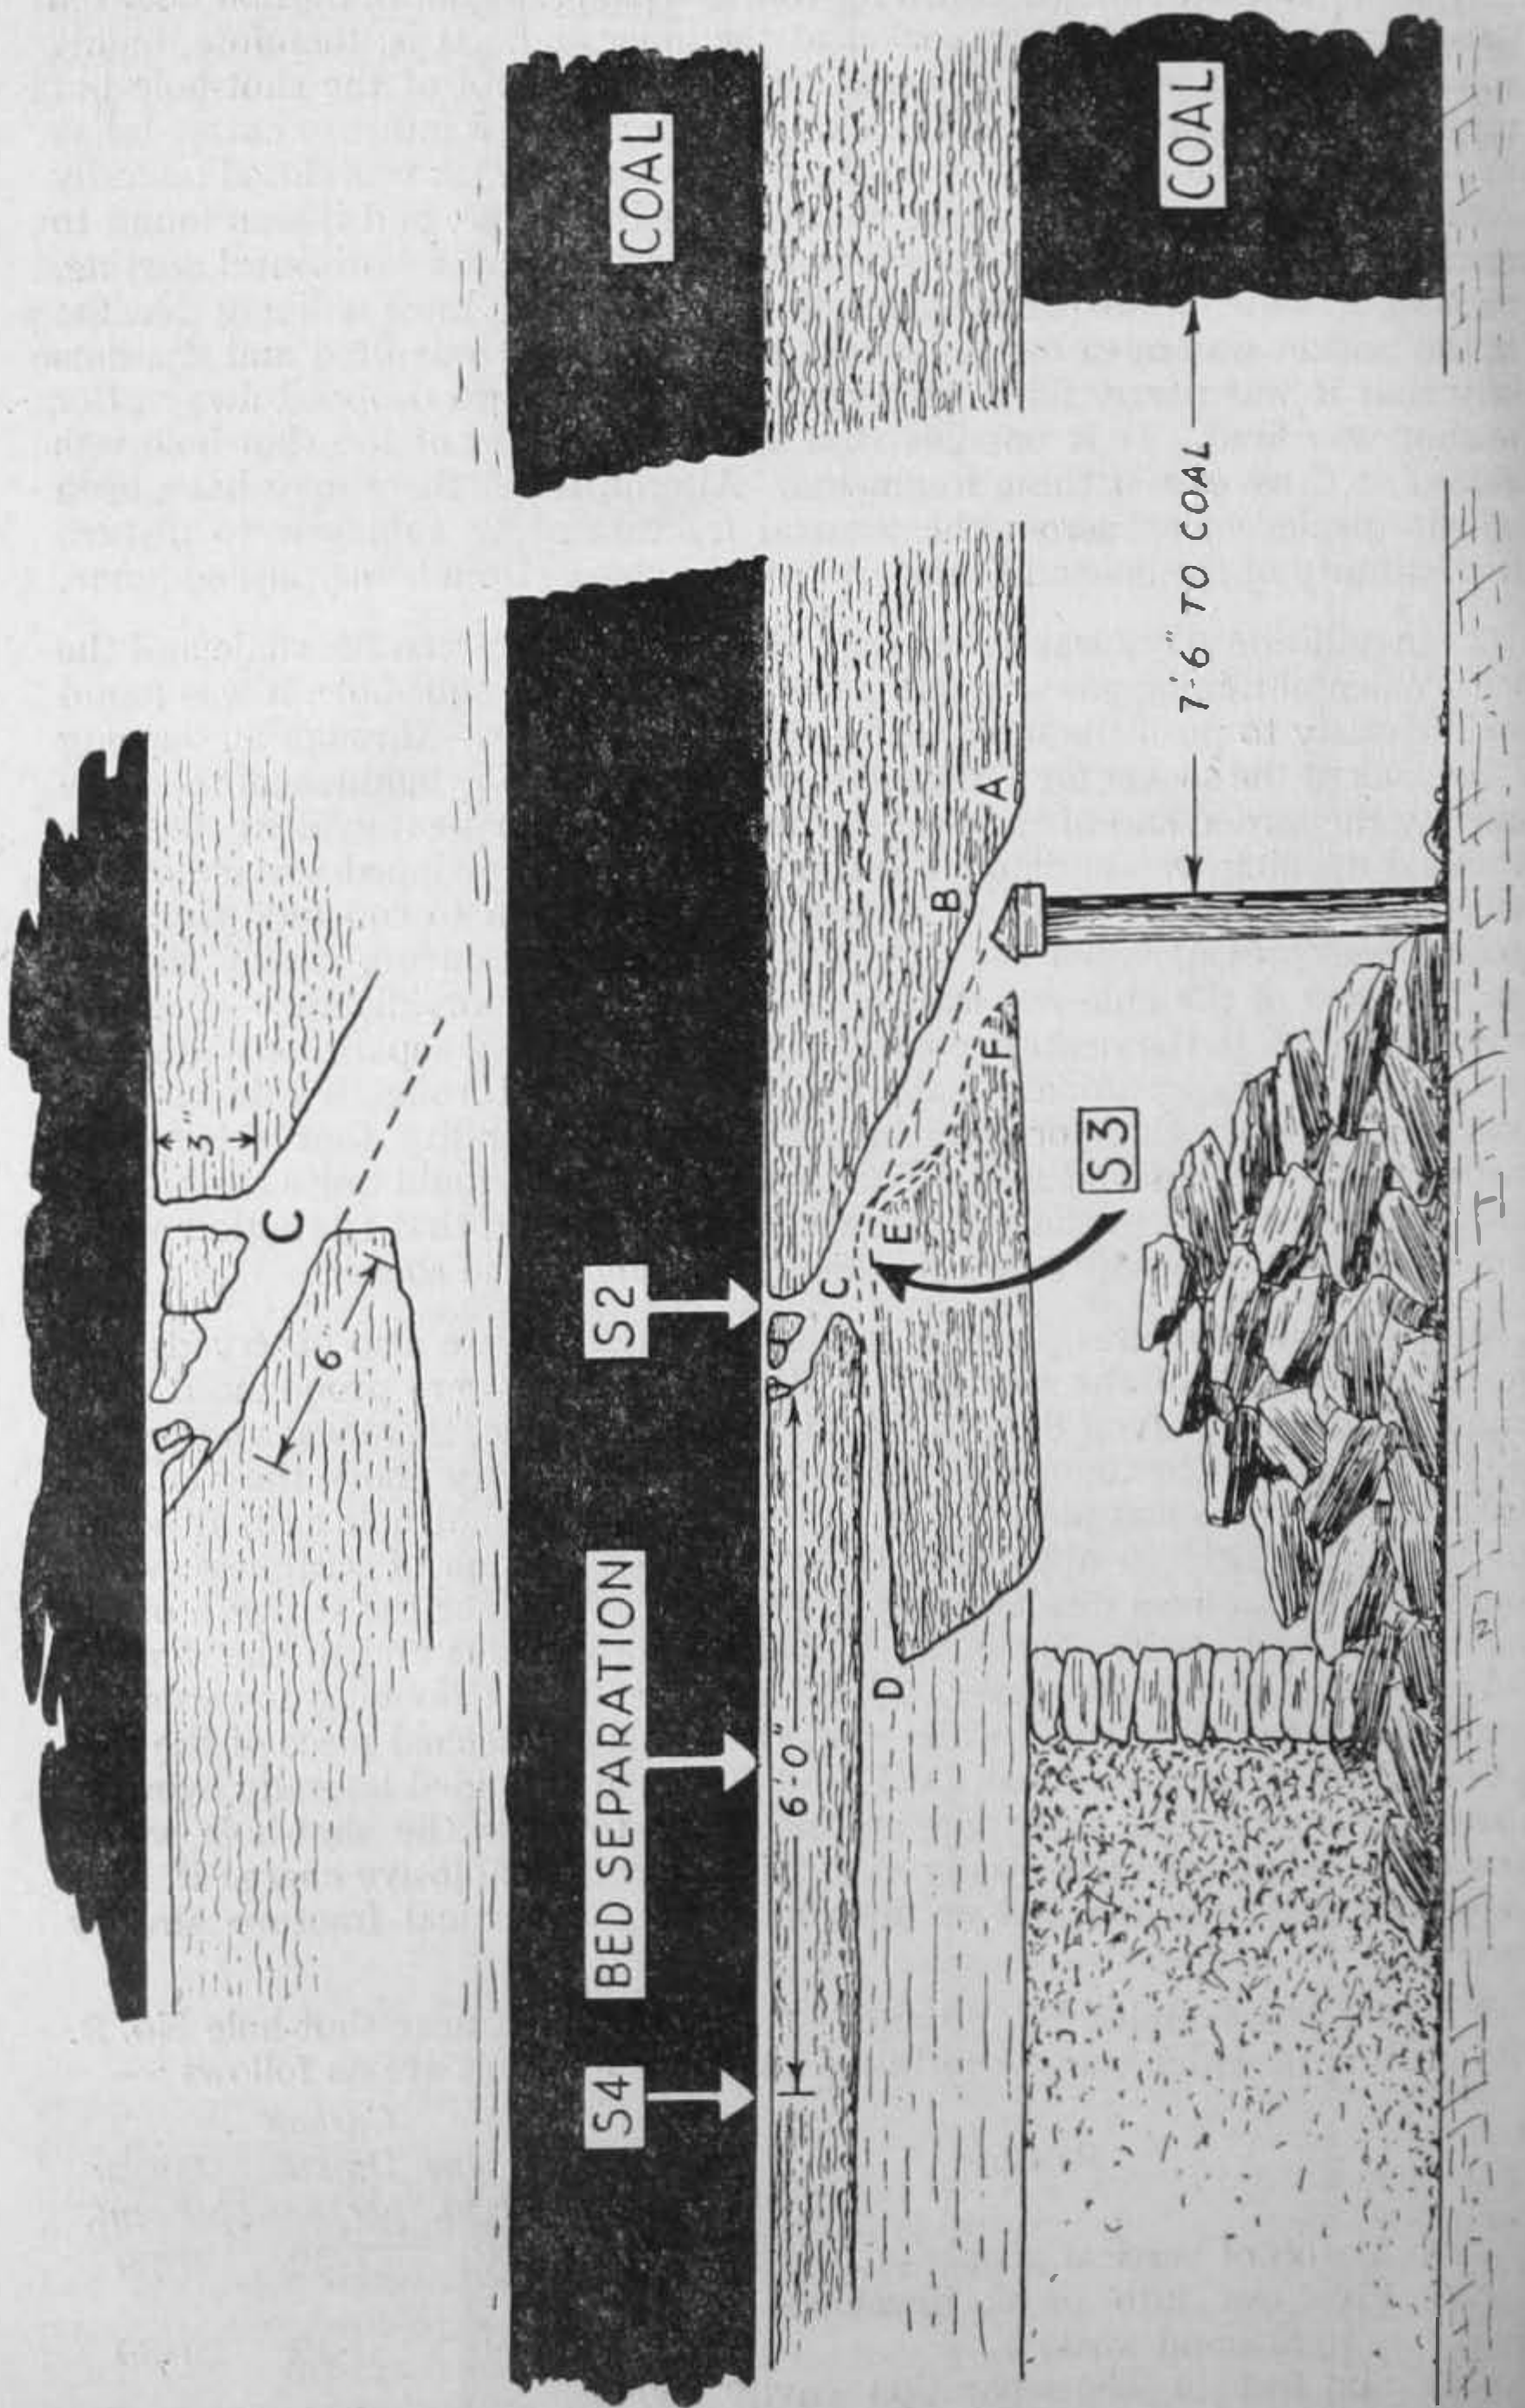
Fig. 3

46. The conditions noted by the same three observers at shot-hole No. 3 are illustrated in Fig. 3. This hole was bored immediately over a prop and the length AB was left more or less intact and partly filled with loose stones. The

firing of the shot had brought down the roof bed along the line of the hole between B and C and there was a 6-in. socket at the inner end. It is, therefore, highly probable that the explosive was not inserted to the end of the shot-hole but only as far as the point C, where there was a vertical roof fracture or cutter-break parallel with the face. As shown in the diagram, this break was closed laterally except for a small vertical pocket which crossed the hole, and it was found to extend upwards for about 3 in., where it was crossed by a horizontal parting, at least $\frac{1}{2}$ in. wide, between the shale and coal beds. It is most unlikely that the vertical pocket was open to this extent before the shot was fired and it seems likely that it was partly filled with rock fragments which dropped away after the shot was fired. It is possible that the cross-section of the shot-hole was reduced at C by one of these fragments. Alternatively, there may have been a slight displacement across the vertical fracture at C, sufficient to disturb the continuity of the hole and thus prevent the charge from being pushed home.

47. In addition there was extensive bed separation between the shale and the coal. When obtaining gas samples in the vicinity of the shot-hole, it was found possible easily to push the metal tube— $\frac{1}{8}$ in. in diameter—through an opening at the back of the socket for a distance of at least 6 ft. The loudness of the noise made by the buried end of the tube during movement made it evident that this extended opening was horizontal and not far above the ripped surface of the roof bed. The experience of the investigators led them to conclude that this opening was present when the shot was fired. Measurements clearly showed that the back of the hole was drilled to within a very short distance—possibly to within $\frac{1}{4}$ in. at the nearest point—of the plane of bed separation, although at the time of the examination there was easy access through a thin layer of broken shale. It, therefore, remains a distinct possibility that this access existed at the moment of firing. The thrust of the drill could quite easily have broken the thin crust of shale for it must be remembered that the action of the shot itself did not produce any marked shattering of the socket.

48. Two other features peculiar to shot-hole No. 3 were also observed. On the ripped surface of the roof bed in the waste there were pronounced cleat planes. Along one, about 8 in. to the left of the shot-hole, there was an opening of about $\frac{1}{4}$ in. which extended to the bed separation cavity above the roof bed. There was another cleat plane $1\frac{1}{4}$ in. to the right of the shot-hole and, although this was not nearly so open, it was nevertheless a plane of weakness which would facilitate a local displacement of the roof and reduce the strength of the shale at the end of the shot-hole. This cleat formed one end of the vertical pocket located at C. Moreover, on the right-hand side (looking towards the waste) of the ripped portion of the roof, there was a detached piece of the roof bed bounded by an open break DEF, Fig. 3, which extended laterally over the waste. The projected extension of this break towards the shot-hole would cross the hole almost tangentially at a point near the explosive charge if, as is likely, the hole was blocked or obstructed at the vertical fracture already described.

The presence of the open cleat no doubt accounts for the lower percentage of methane in the sample taken some distance in the bed-separation cavity, but it is significant that the atmosphere here was inflammable and capable of self-propagation of flame at a slow speed.
